Manhole Inspection Summary

Manhole # S45UU_016MH

Insp Date: **2/6/07 2:36 PM**

Location Address: **1809 28TH ST**

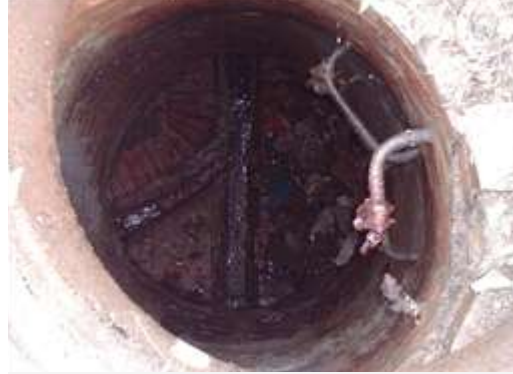
Top View

Corroded and missing steps. Evidence of surcharge - Bench debris.

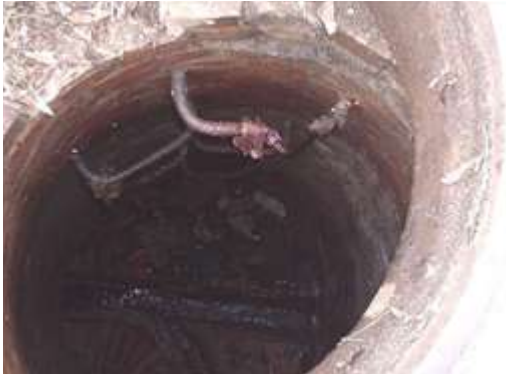
Defect

Frame leaks. Frame offset. Adjustment deterioration and infiltration. Corbel and Barrel infiltration.

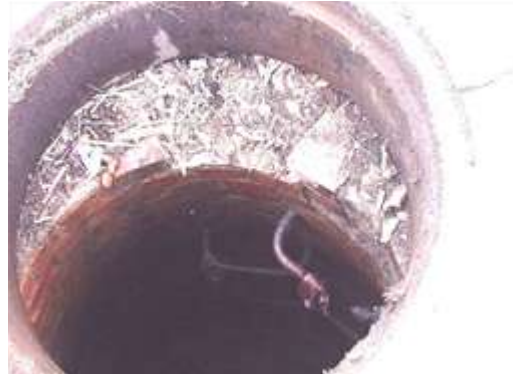
Defect

Frame leaks. Frame offset. Adjustment deterioration and infiltration.

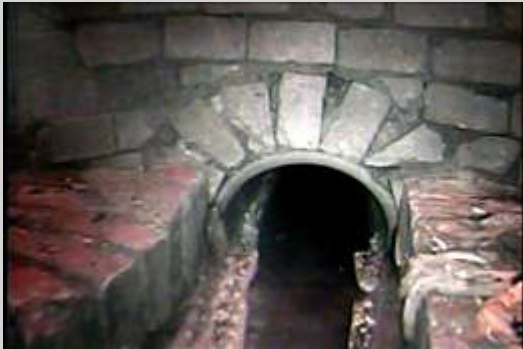
Pipe Out @ 12 O'Clock

Deposits: ☐ None ☐ Mud ☐ Sludge ☐ Debris ☒ Grease

Silt Depth: **0** (in.) Deposits Extent: **Light**

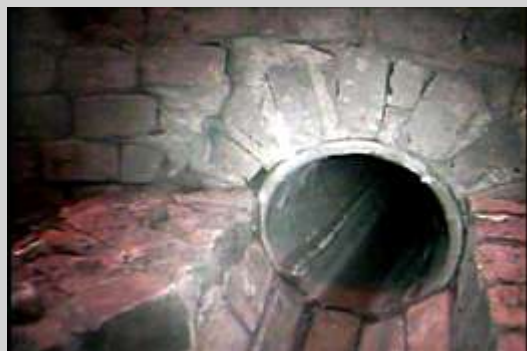
Pipe In @ 9 O'Clock

Barrel deterioration and infiltration.
